# Kepier Water Mill, Durham City: A Conjectured Reconstruction

John M. Coffey

March 2017

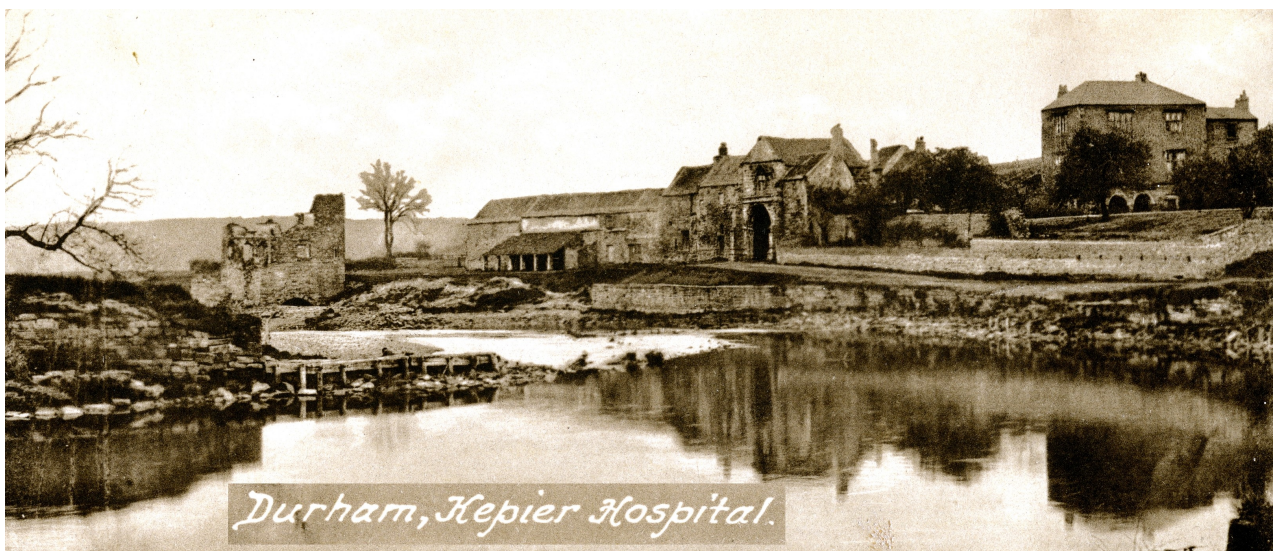
Figure 1: Photograph of Kepier Hospital taken in 1886 from the upstream southern river bank looking north. (Frith postcard, courtesy Durham Record Office)

According to Kirby the mediaeval mill dam was essentially a wooden box framework filled with stone and caulked with packed moss. Each year the moss had to be repacked to limit leaks. Where the dam joined the river bank, strengthening was needed and a stone or brick wall was usually constructed. Kirby reports (page 54) that as late as 1860 the dam at Kepier was reconstructed in this ancient manner even though stone dams had by that time become the norm. All these features can be discerned in Figure 1.

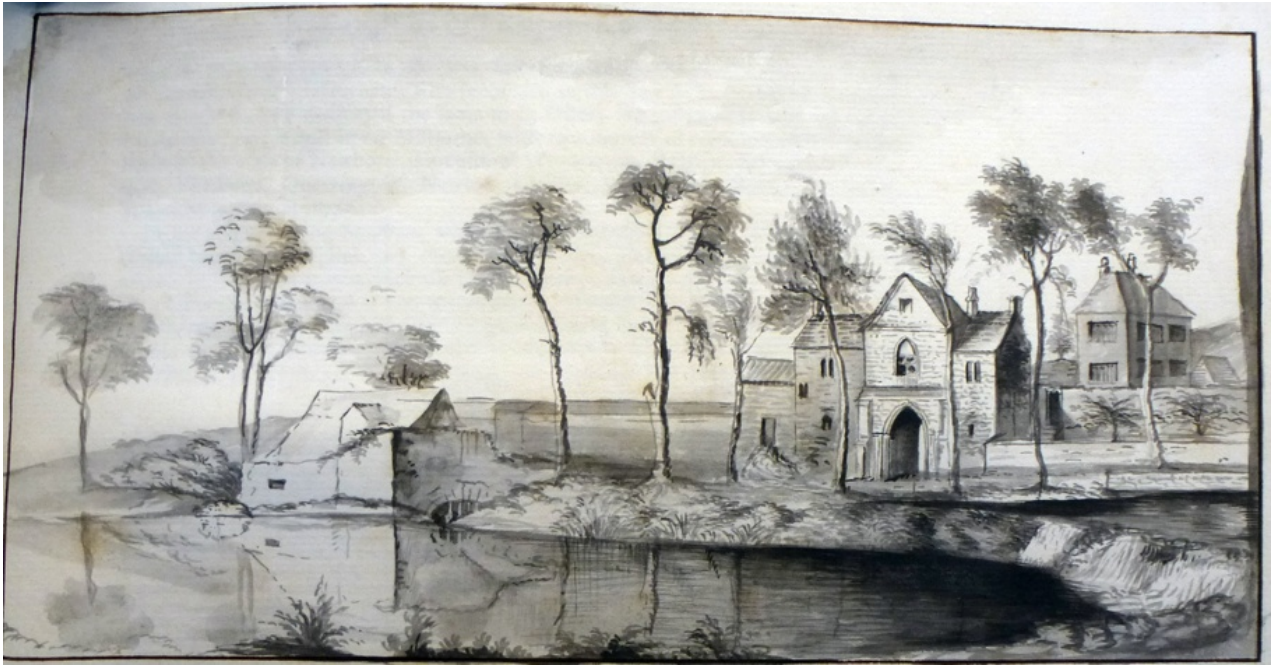
Figure 2: Brush and wash drawing of Kepier c1780 in Hutchinson's book, Durham Cathedral library.

modified over the centuries as technology advanced and demand increased. In the Musgrave papers is an bill paid to John Horne for work between August and November 1679 making new mill wheels. The next year, in March 1680, Sir Christopher contracted with Nicholas Palmer, a freemason of Elvet, Durham, for £20 for repair of ‘the mill dam crossing over the River Wear at Keeper between the fifth lock to the further landstaple on the other side of the river and the same landstaple’. There was a surveyor’s assessment of the Kepier estate in 1757 when the mill tenant was Anthony Dobson. The comment is ‘(lease) Expires 1759. in exceeding bad repair’. We may assume it was in even worse condition after the massive floods of 1763 and November 1771, when bridges and houses in Durham City and indeed across all North East England were swept away. Figure 2, therefore, probably shows the mill at its most dilapidated.

The brush and wash picture in the Hutchinson book, Figure 2, shows the mill and dam from the west bank of the river. It is not particularly well drawn, and the perspective on Heath House is poor. The mill building looks to be single storey, perhaps 30 feet long, 10 feet above ground level at its entrance. The water inlet archway has a grid over it to prevent debris entering, and the wall above the grid, perhaps 10 feet high, appears broken at its top, as if it were the remains of an earlier mill structure. The main part of the building seems to be built behind this archway wall, not attached to it, since what looks like the branch of a tree overhangs the archway wall. A small wing, with its own pitched roof and gable against the river, projects at right angles from the main building. There is no sign of the water wheel. The long island of earth which forms part of the dam is overgrown with grass, and in the pool below the dam the water is still so we see clear reflections.

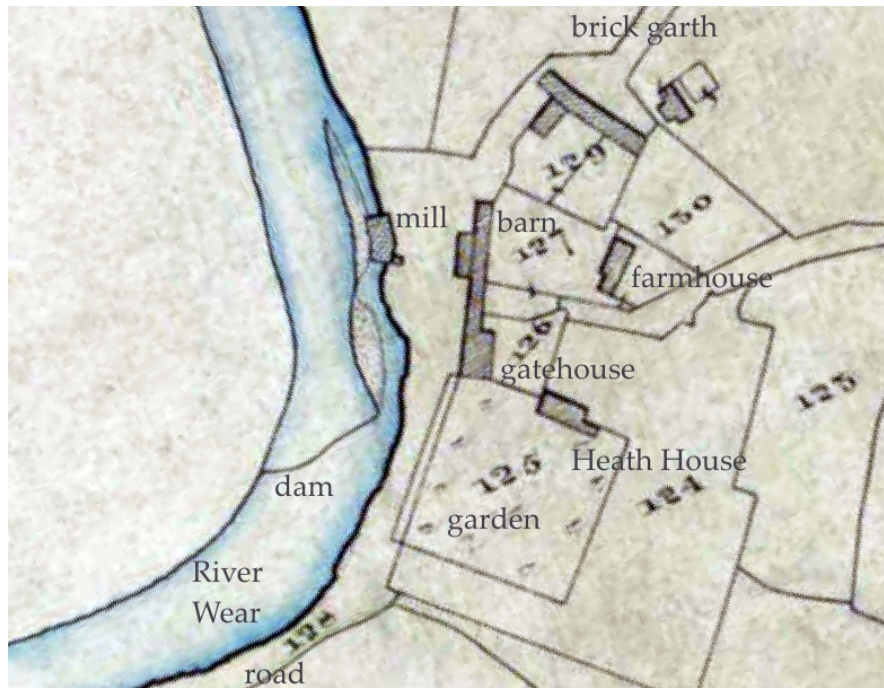
Figure 3: Detail from tithe map of St. Giles parish, 1845.

Some old maps give an impression of the rebuilt mill, after 1800 [13]. Figure 3 is a detail of the tithe map of the parish of St. Giles, Durham, dated 1845. Figure 4 is drawn from Ordnance Survey (OS) maps surveyed of 1857 and 1894. It is frustrating that the mill building lies exactly in the edge of two map sheets, so the drawing is made by joining sheets to the south and north. Figure 5 is drawn from the OS map revised in 1895, surveyed after the mill had burnt down. Let us take these maps in date order.

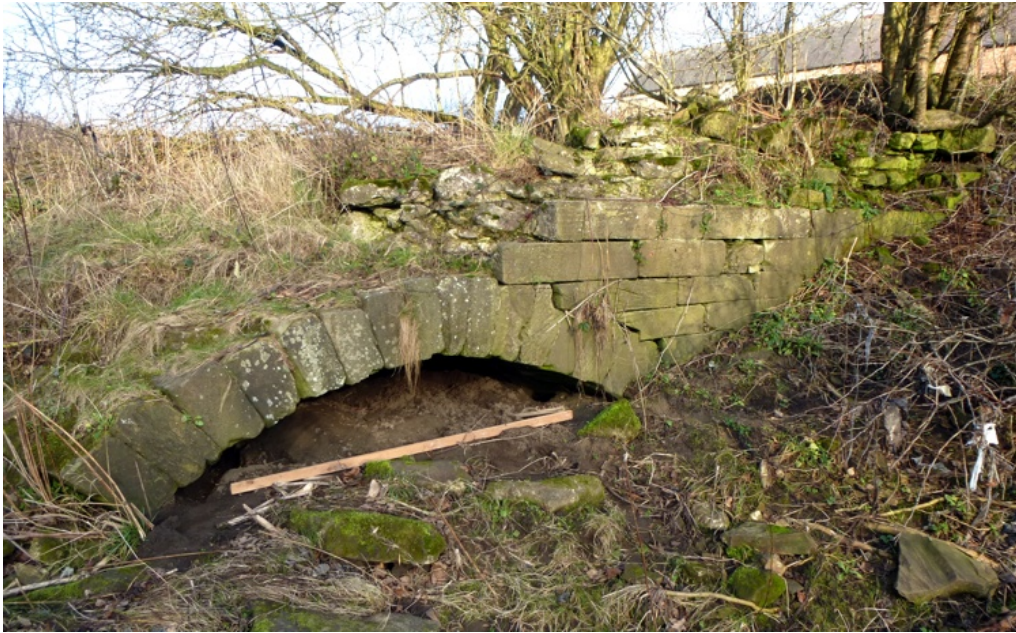
Figure 8: The silted up mill arch in February 2017. The wooden stick is 68 inches (172 cm) long.

room set into the steep river bank. I have taken the walls of this lower level to be made of stone blocks as in Figure 8, and the higher parts of rougher stones as with the gatehouse. The rooves are tiled. The height from top of mill arch to eaves is 32 feet, and the water wheel is 9 feet wide, 12 feet diameter. I suppose that the top floor of the mill was used for additional grain and equipment storage, and that the wool spinning machine was installed up there too, perhaps in a partitioned-off room. In the right panel of Figure 16 the nearer walls have been cut way to show the floors, stairways and milling machinery, in keeping with Figure 12, 13 and 14. The right panels of Figure 15 and 16 show a second hoist on the top floor working with an external cantilever beam and a loading door so that sacks of grain could be lifted straight from a cart direct to a hopper.

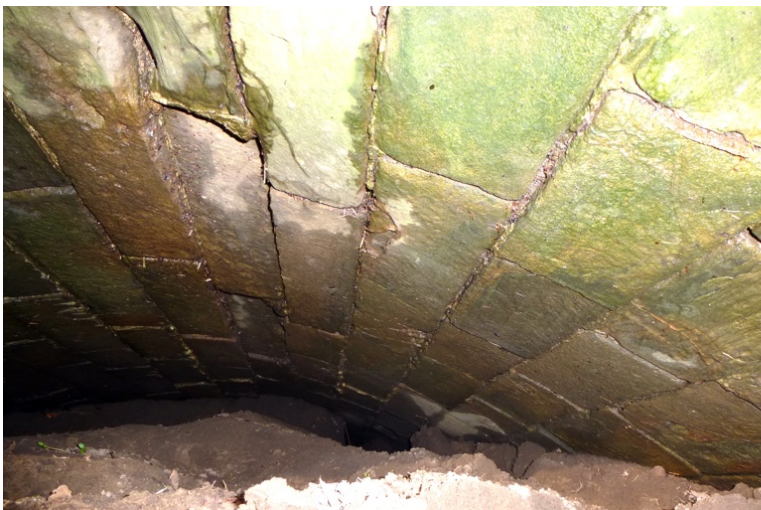
Figure 9: Left: Stone roof, looking into the arch. Right: Sketch plan of remaining stonework.

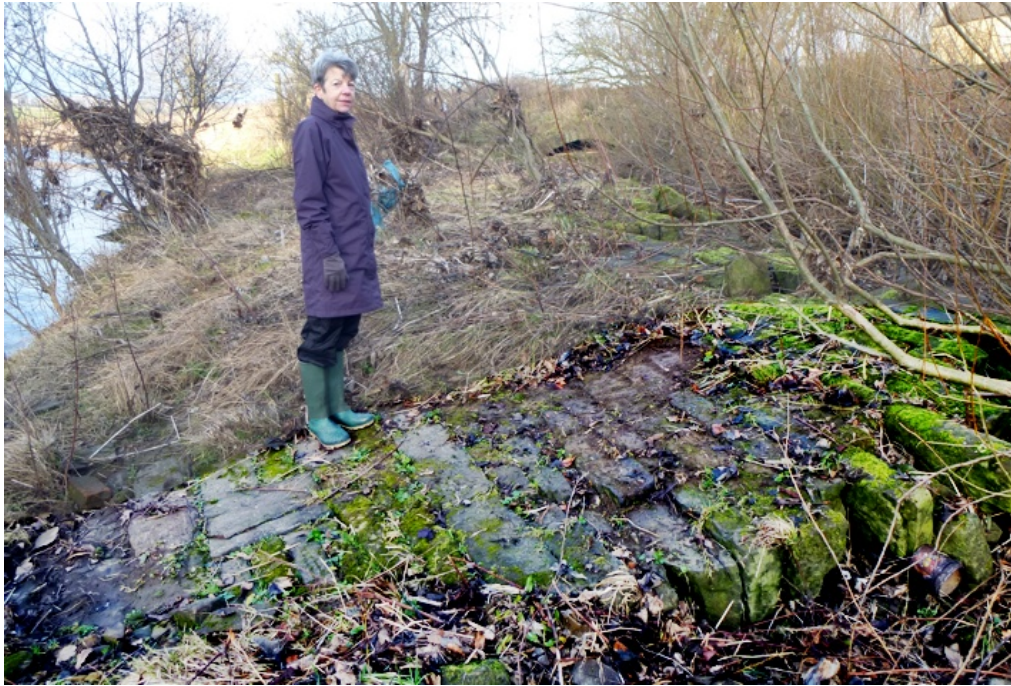
Figure 10: Large cobble stones set in the earth bank upstream of the arch. They slope gently towards the river at an angle measured as  $11^\circ$ .

The earth mound upstream of the arch is paved with large stone cobbles, a sample of which is shown in Figure 10. (The image contrast has been enhanced in the foreground.) I identify these with the array of small rectangles in the 1896 OS map, Figure 5. There are two parallel decayed and broken lengths of wood about 3 feet (1 m) apart, with stone block paving between them, jutting over the river's edge a few metres upstream of the arch. Perhaps they were part of a track, or a landing stage for grain or stone from Keping quarry, or coal from the drift mine a mile or so further downstream.

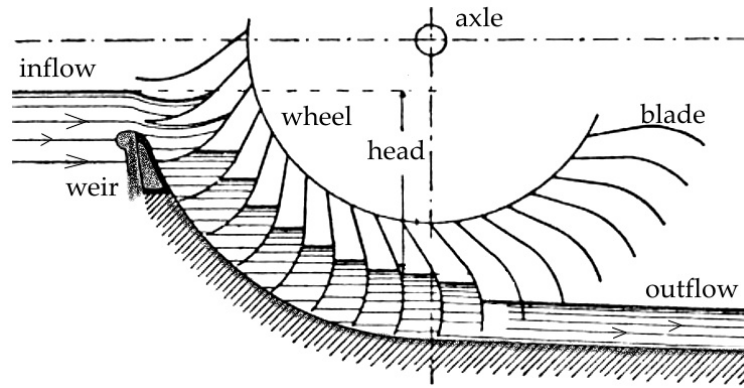
Figure 11: Section through an undershot mill showing how the blades and curved stone under-surface trap the water in compartments which fall as the mill turns. (after W. Müller).

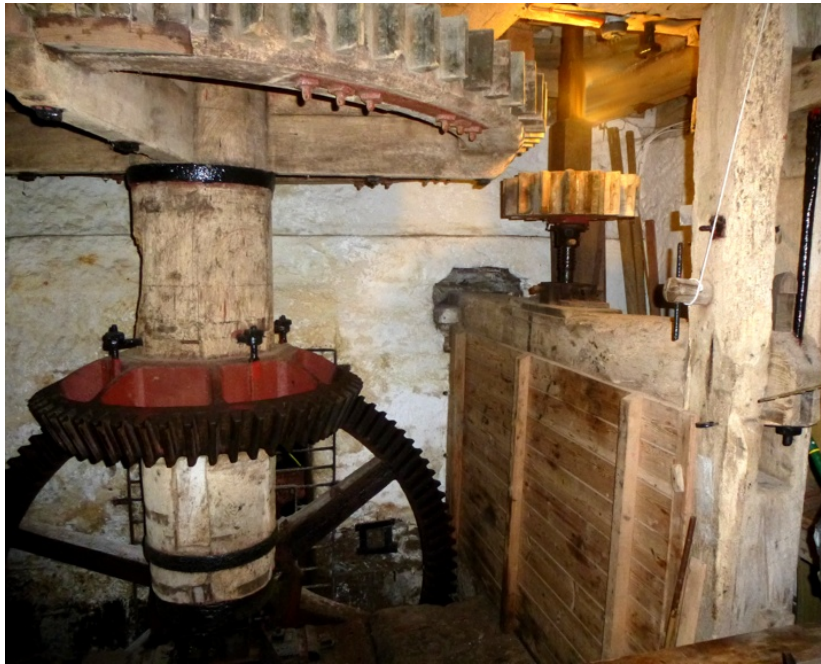
Figure 13: The pit wheel, wallower, upright shaft, great spur wheel and one of the stone nut gears at Stretton water mill, Malpas, Cheshire.

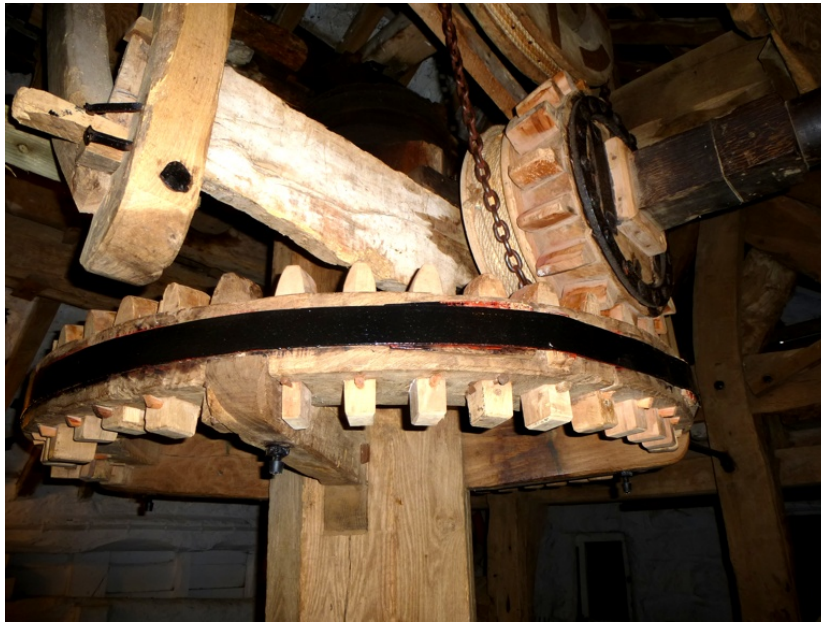
Figure 14: Wooden peg teeth in the crown and pinion gears at the top of the upright shaft at Stretton water mill, Cheshire.

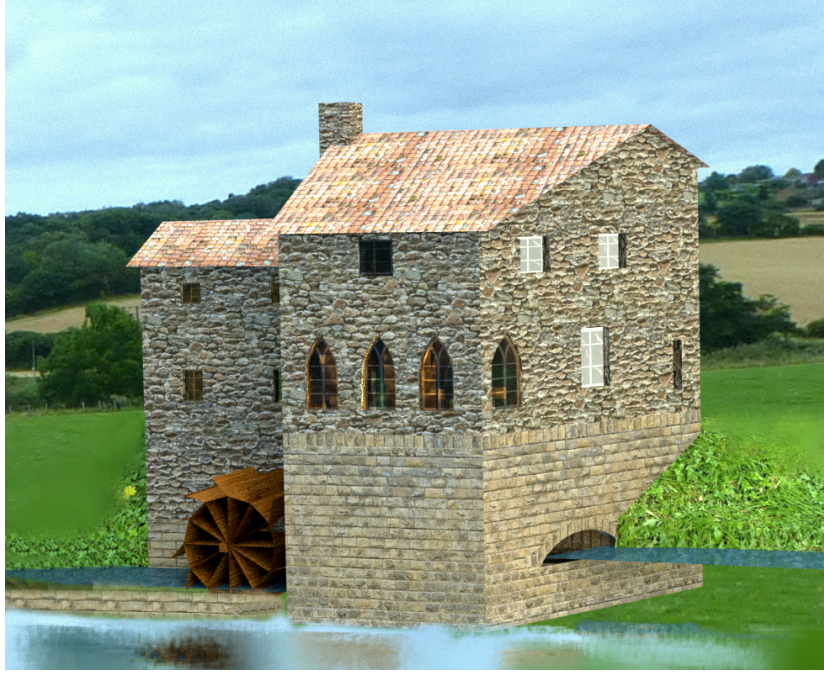
Figure 17: Mesh model augmented by adding textures and a background to represent the mill as conjectured in the early 19th century. The diagram is cut away at water level.

I have tried to consolidate the scraps of information we have on Kepier mill by making a computer model of what it may have looked like in the 1850s. The result is essentially a computer ‘Lego’ model of the mill buildings, capable of being rotated in 3D on the screen and hence viewed from any direction. The software has the facility to hide selected components so that, for instance, a wall can be made invisible so we can see inside the building. I used a finite element analysis program called Mecway ([www.mecway.com](http://www.mecway.com)) usually used by structural engineers to calculate stress and deflection in loaded bridges, etc. The model is made by forming single brick-like elements and stacking them together into walls, beams, wheels, etc. In these images the faint lines delineate 1 foot cubes. The Mecway software allows colours to be chosen for the various parts of the structure, but does not apply realistic brick or stone textures or lighting conditions. In Figures 15 and 16 are four views of the basic mesh model. The ground level is shown together with sections of wall below ground. I augmented this by using the Blender 3-D graphics program ([www.blender.org](http://www.blender.org)) to add masonry textures and from this produced Figure 17.

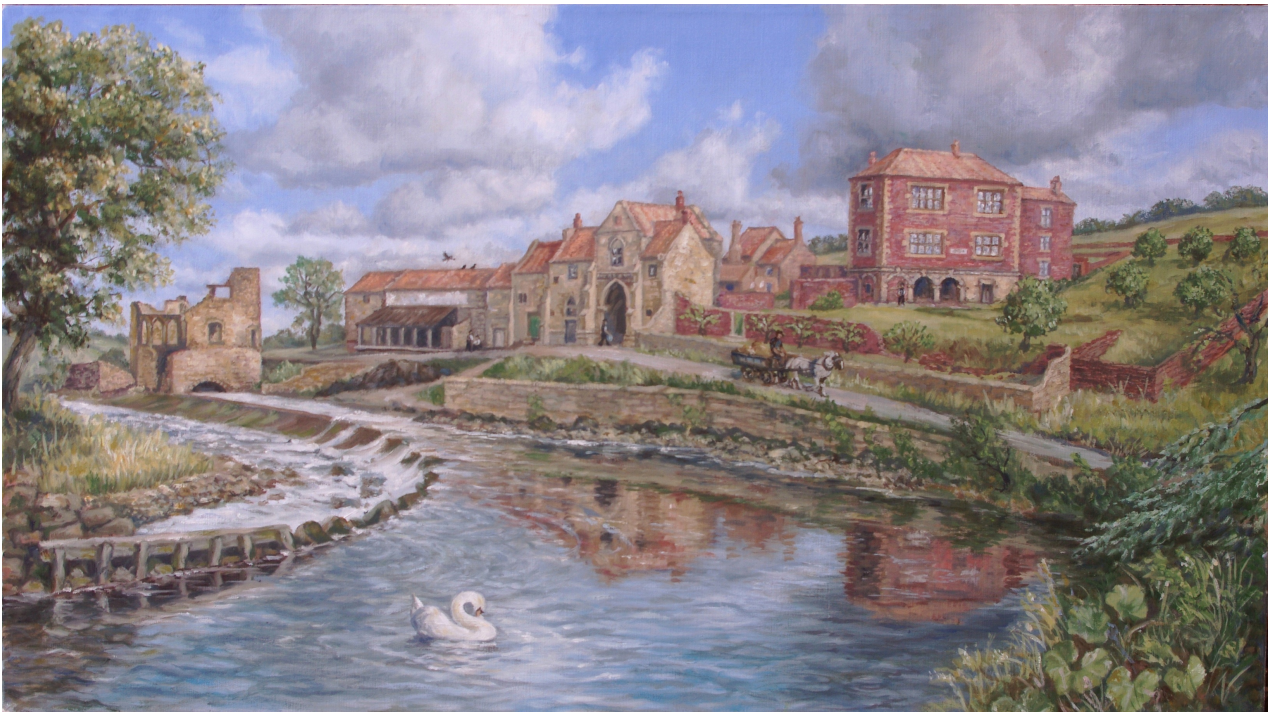
Figure 19: Painting by the author based on the Frith and Gibby photographs of about 1880.

Having made the model I simulated the destruction wrought by the fire of 1870. This was done simply by deleting selected mesh elements until the ruin looked like the photographs. Figure 18 places the model ruin alongside the Frith photograph. Personally I feel that the agreement is good enough for me to complete my painting – Figure 19.
